LAUREL HILL HOUSE

Historic Structure Report and Treatment Options

D. Building Description and Condition Assessment**1. Architectural Description and Condition Assessment****a. Synopsis**

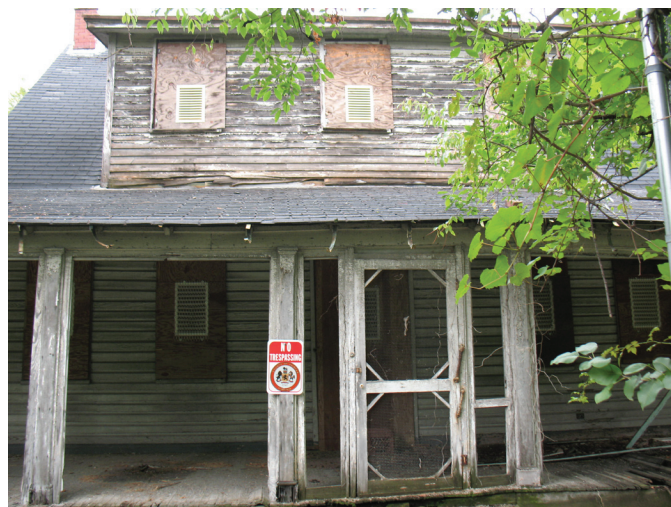
The wraparound porch was added by the time of photos dating to the early-twentieth century. The porch has some interesting details including shaped rafter tails and engaged columns on posts that create a paneled appearance by tracing the porch openings with moldings (Photo X2). The tongue-and-groove floor and its supporting structure are showing severe distress and collapse in some areas (Photos X3, X6 and X15). The beaded tongue-and-groove ceiling boards are similarly in varying states of disrepair (Photo X3). Deflection can be seen in the roof structure above the northwest end of the porch. The entire porch is severely deteriorated, and parts will likely collapse in the near future (Photos X6 and X15).

Close-up view of porch on front (south) side of building. (X2)

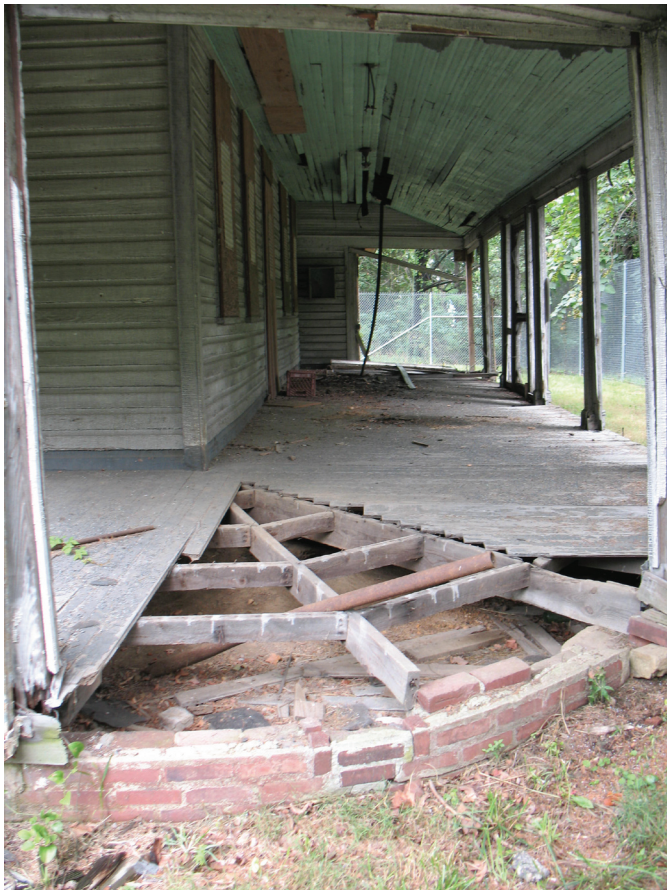
Detail view of southwest corner of house. (X3)

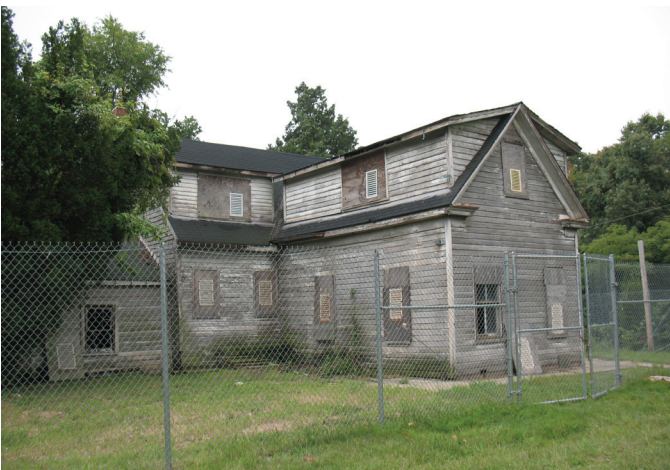
View of house from northeast side. (X8)

The windows are typically double-hung wood sash windows with some casements seen in the one-story additions. Few of the original six-over-six sash windows remain. They were replaced with two-over-two windows, possibly at the time the rear addition was added. While the windows are covered with vented plywood, their condition varies from fair to poor (X7, X8, X9, X10 and X12).

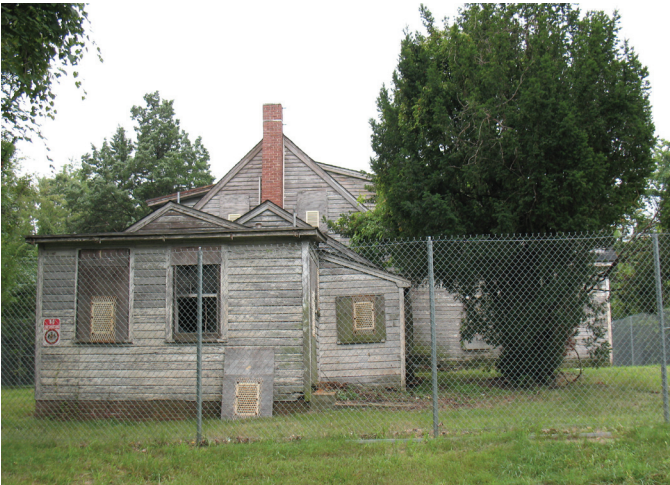
View of building from the east side. (X12)

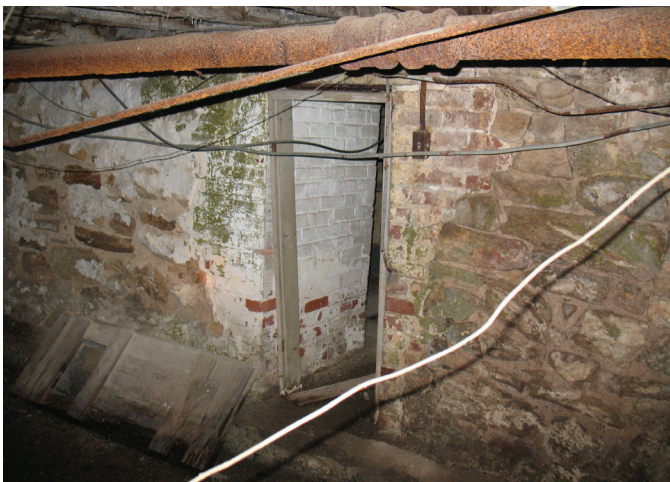
Basement view of door to small room added to north side. Note prison-era bricks used to create door opening in stone foundation. (B01-2)

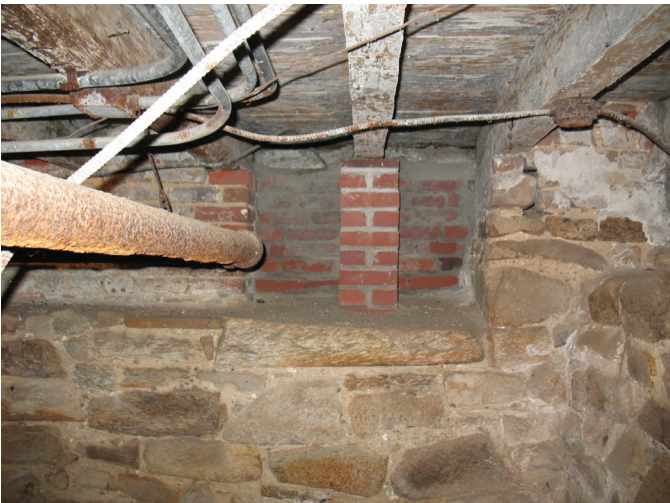
On the east side of the basement, more modern dimensional framing can be seen along with rusty steel girders. Brick piers, that utilize prison-era brick, have been used to supplement or replace the original basement structure (B01-3).

Basement view of brick pier added at window opening on south side of foundation. (B01-5)

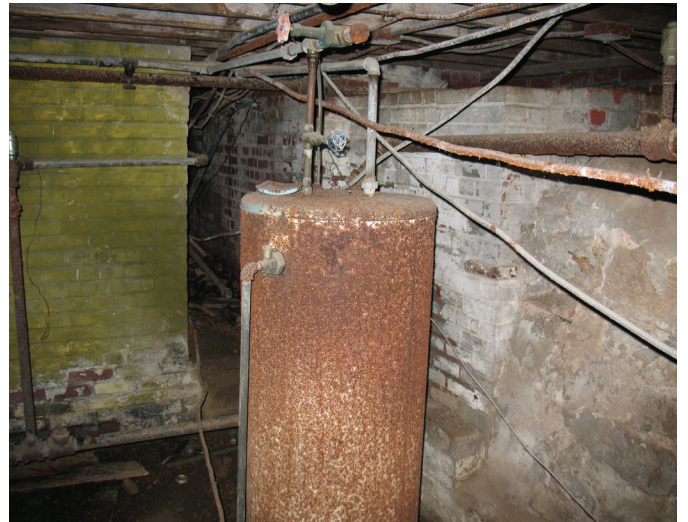
Most of the rest of the building is built over a dirt crawl space. An areaway for pipes extends from the stand-up section of the basement toward the additions (Sections 2 & 3) on the east side (B01-10). A small room, possibly for coal storage, extends under the south addition.

Basement view facing southeast. Note transition from stone to prison-era bricks in foundation wall. (B01-10)

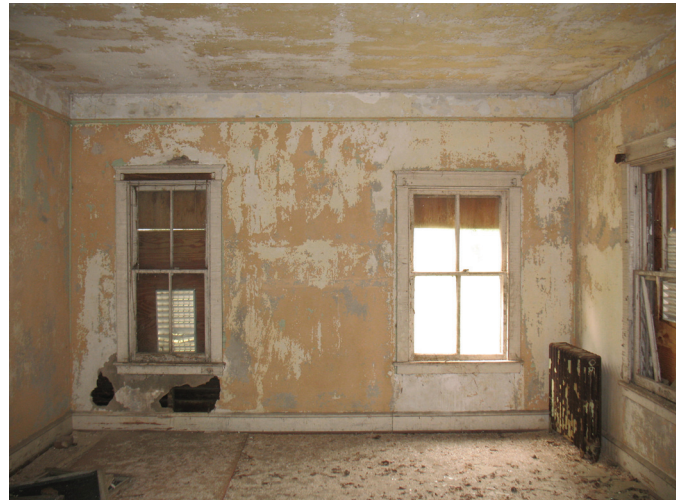
View of windows on north side of rear addition. Note indications in base and plaster of right window being converted from door to window. (102-2)

Much of the paint has peeled off the plaster walls and ceiling. A significant area of water damage has occurred in the southeast corner of the room. The wall and ceiling plaster, along with the floor, is damaged in this area.

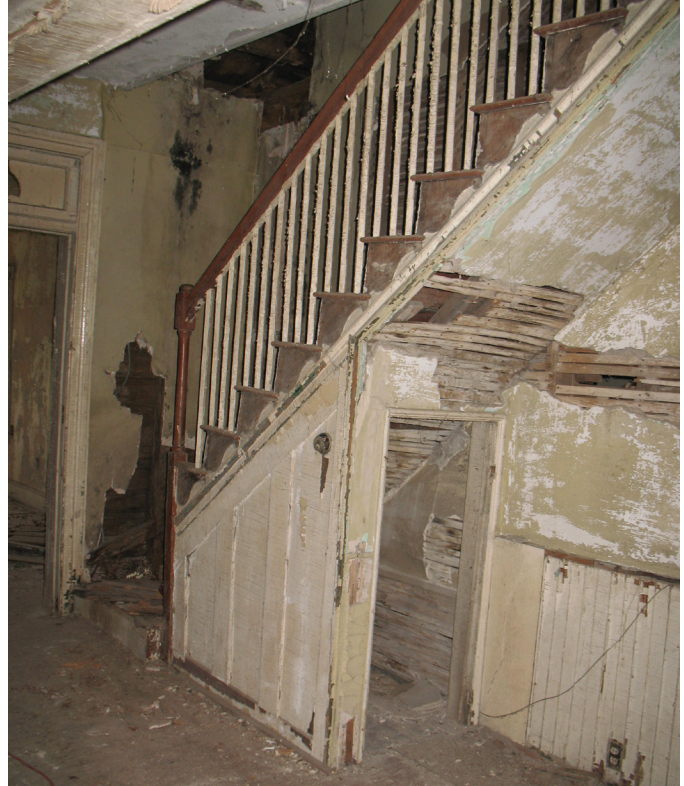
View of original stair railing in original hall. (103-1)

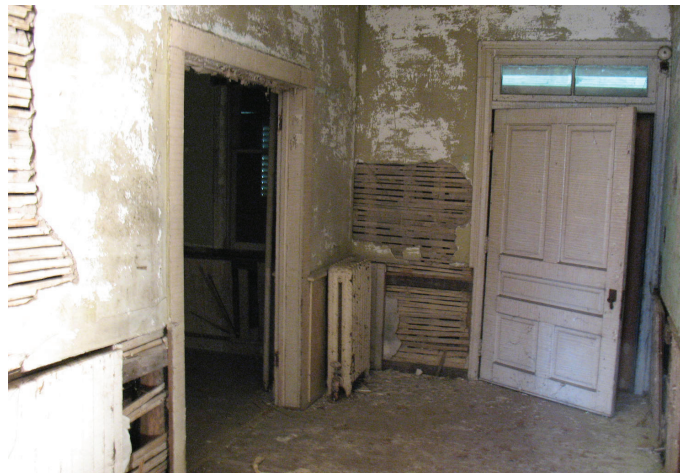
A large five-panel door and transom have replaced the original front and rear entrance doors (103-2). These doors have a casing profile that is also seen at one door and the gable windows on the second floor.

View of original hall facing entrance door. (103-2)

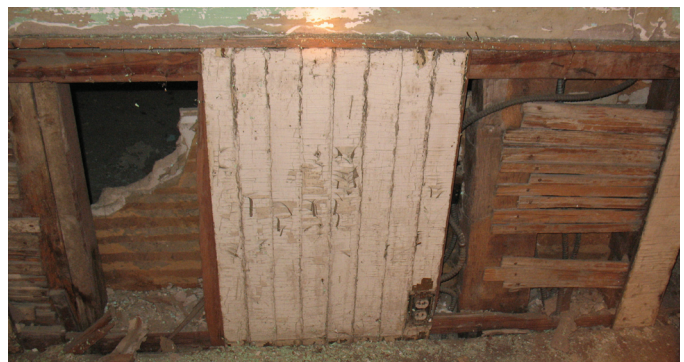
This room was the hall in the center passage scheme of the original house. The remaining plaster appears to be original since it is installed over split wood lathe. There is what appears to be original beaded-wood chair rail and base behind the tongue-and-groove wainscoting (103-3). The wood wainscot was likely added at a later date and has suffered considerable damage and abuse. It has been covered with painted plywood in some locations.

Detail view of remaining split wood lathe and original base and chair rail in original hall. (103-3)

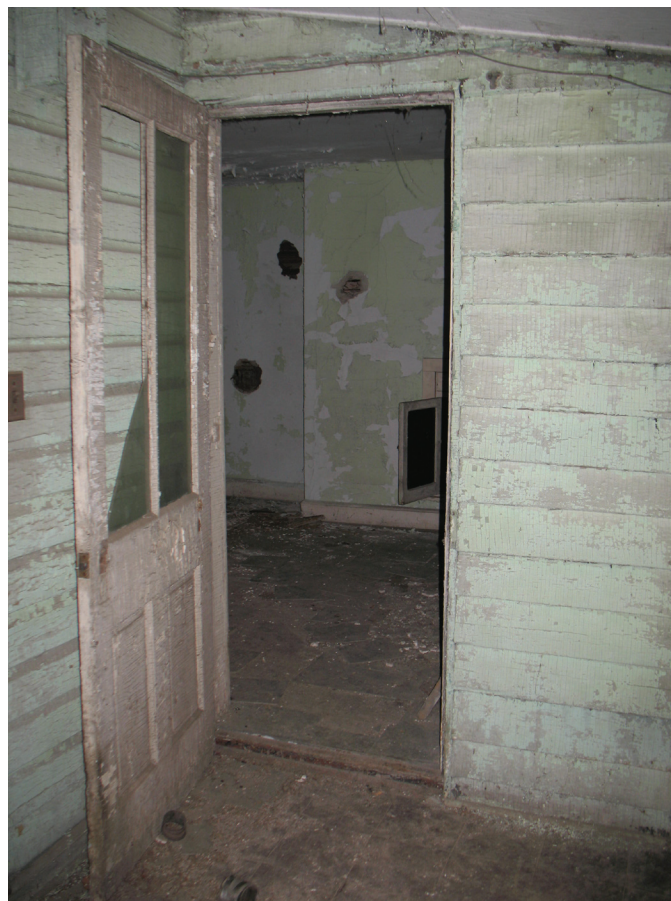
This foyer appears to be an enclosed porch. It has a variety of wall finishes. The west wall is finished with what is likely the original clapboard siding on the exterior wall of the house. German siding is used on the south wall (109-1). The east wall is plaster and the ceiling is finished with painted hardboard with lattice strips covering the joints. The north wall is finished with tongue-and-groove beaded-board.

View into room 106 from room 109. Note German and clapboard siding on the south and west walls, respectively. (109-1)

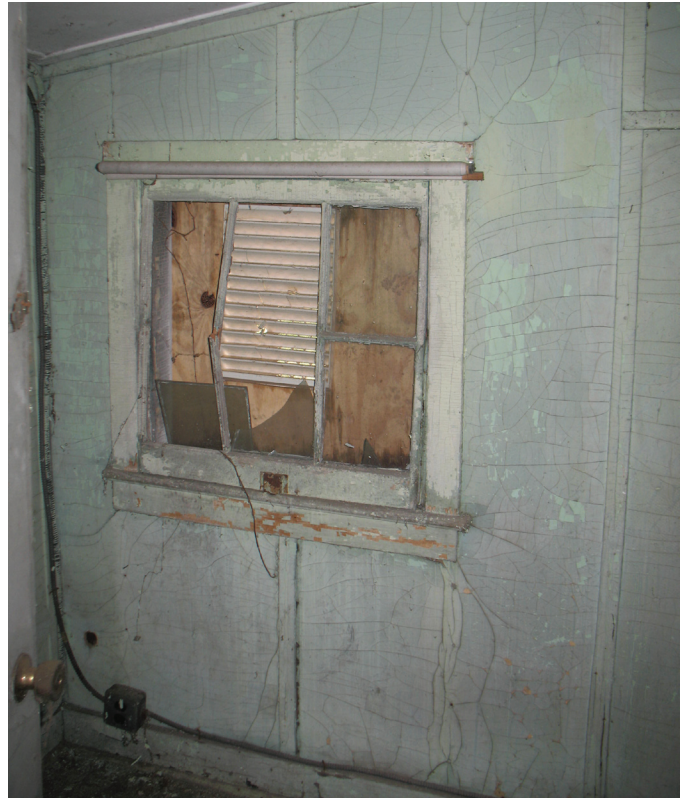
View of casement window and hardboard wall finish. (110-1)

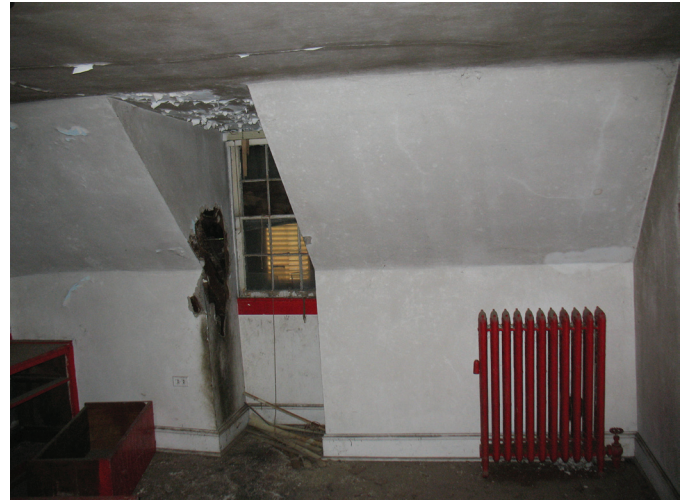
View toward the rear dormer window in Room 201. (201-1)

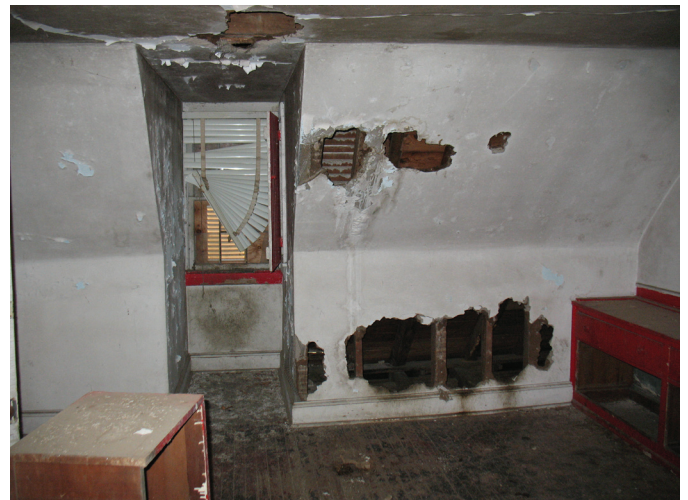
View toward the front dormer window in Room 201. This dormer was incorporated into the shed dormer on the front of the house. (201-2)

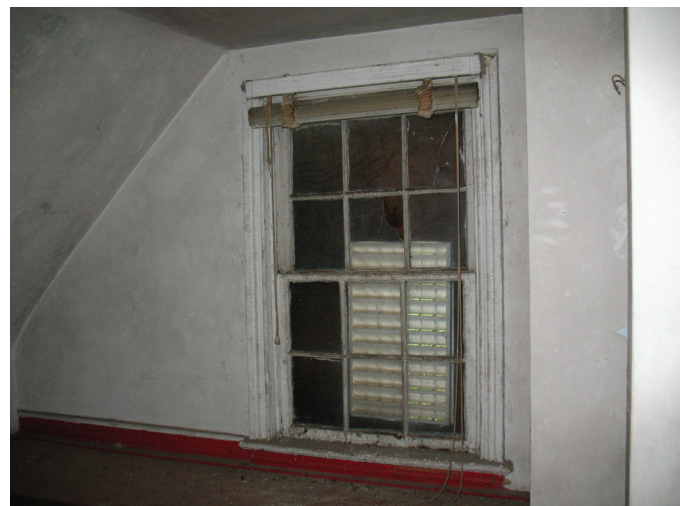
The molded casing at the gable-end windows has the same profile as used at the front entrance door (201-3). A narrow piece of molded trim is the only casing at the dormers. The two-piece baseboard consists of a one-inch nominal trim board and an ogee cap, a likely replacement of the original.

View of window in gable end of house. Note the six-over-six light pattern and molded trim. (201-3)

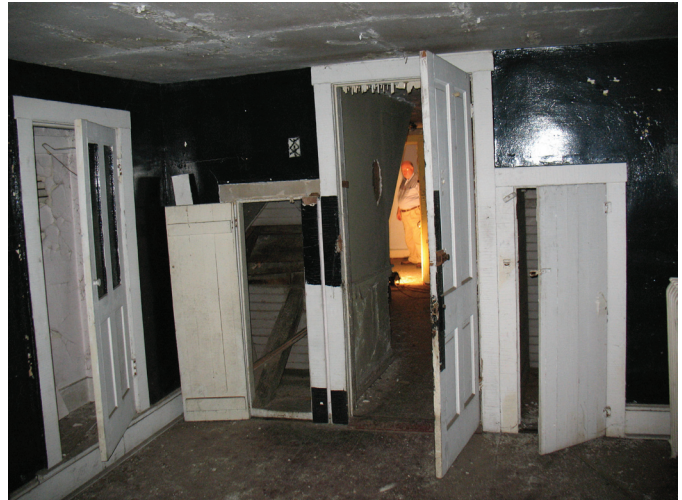
According to a suggestion from the Laurel Hill Committee, this room may have been used as a “safe room” during the prison era. The extra bolts seen at the entrance door and the dark color of paint may be evidence of this use.

View toward entrance door of Room 202. (202-1)

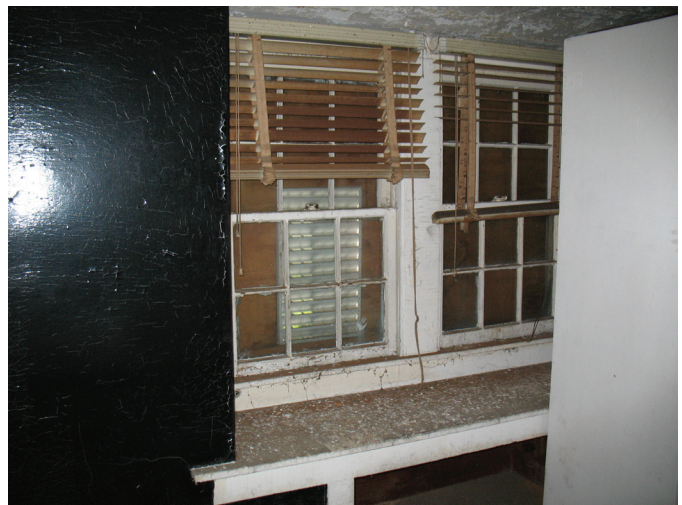
View of windows in shed dormer in Room 202. (202-2)

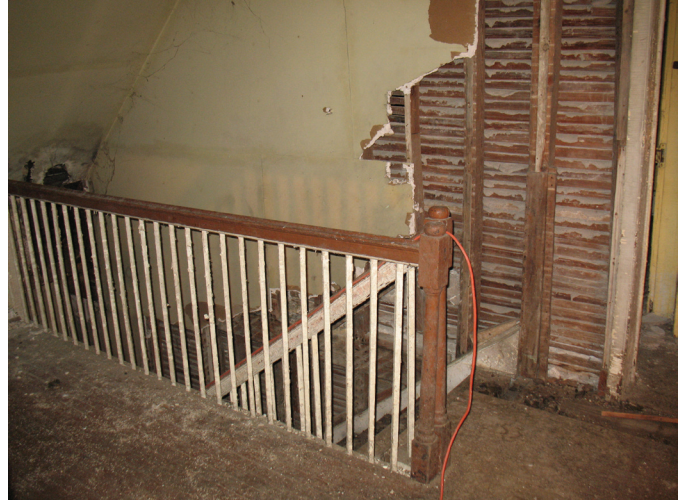
View of likely original railing in second floor hall. Note double newel post. (203-1)

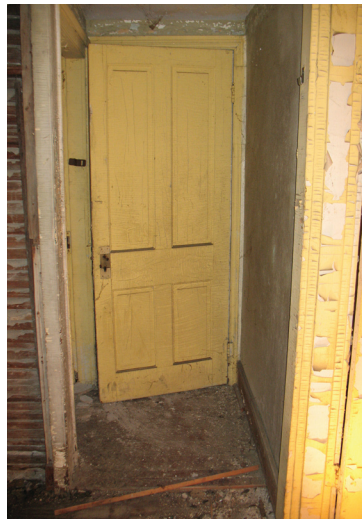
View down short hall toward bathroom. (203-2)

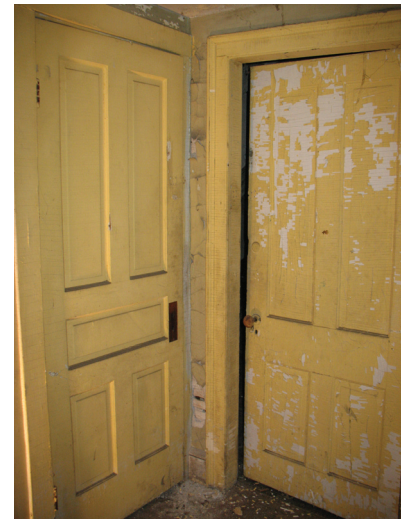
Close-up view of doors in hall. Note likely original casing on door to right. (203-5)

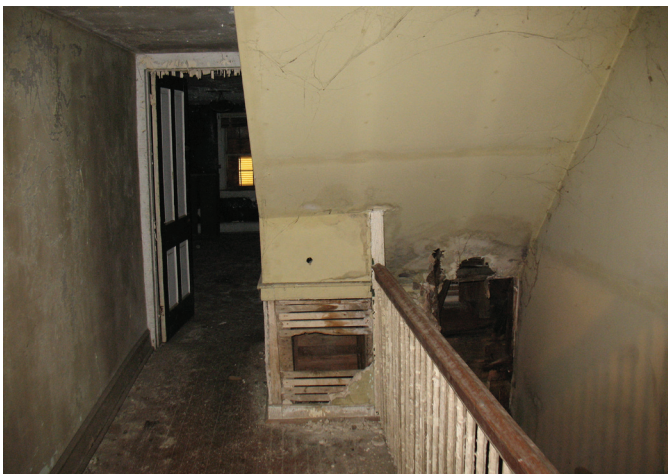
Much of the original plaster has been replaced with new plaster on rock lathe. Some of the original wood lathe can be seen under the chair rail. Gypsum board is installed and partially removed along the stair (203-3).

View toward room 202 at rear of house. Note location of likely original chair rail and base on section of wall missing plaster. (203-3)

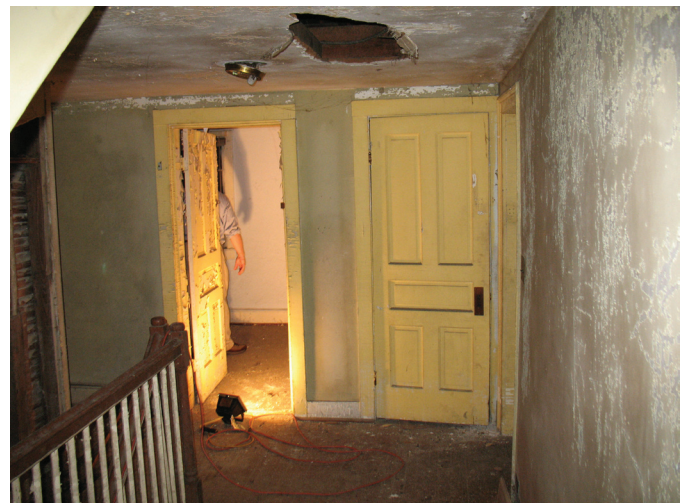
View of hall toward front of house. (203-4)

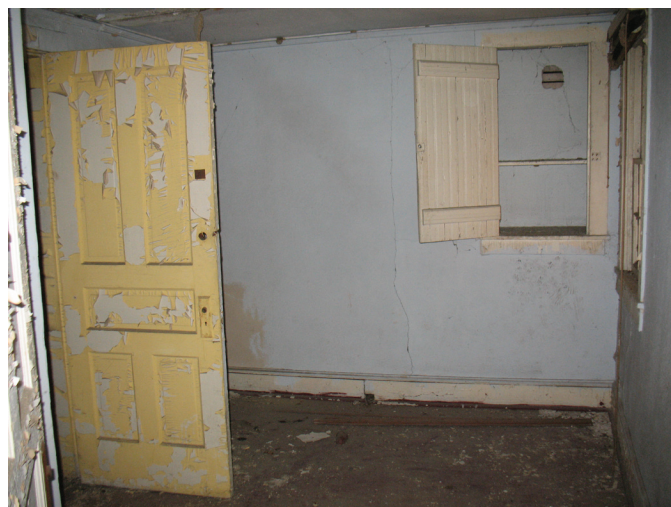
View of Room 204. (204-1)

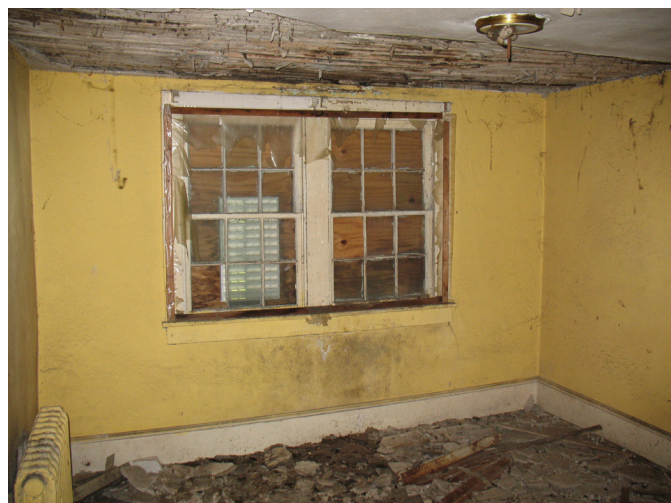
The door is four panel. The windows have six-over-six light patterns. There is an unusually tall two-piece base consisting of a one-inch nominal trim board and an ogee cap (205-1).

View toward shed dormer to rear of the room. (205-1)

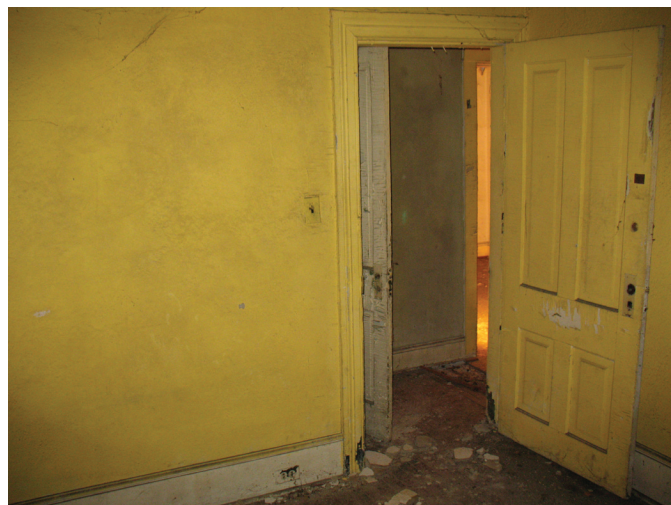
Molded wood trim similar to the front entrance exists at the door and the gable window (205-2). Flat trim surrounds at the shed dormer window. Floors are tongue-and-groove oak. The overall condition of the finishes in the room is fair to poor.

View toward front of Room 205. (205-2)

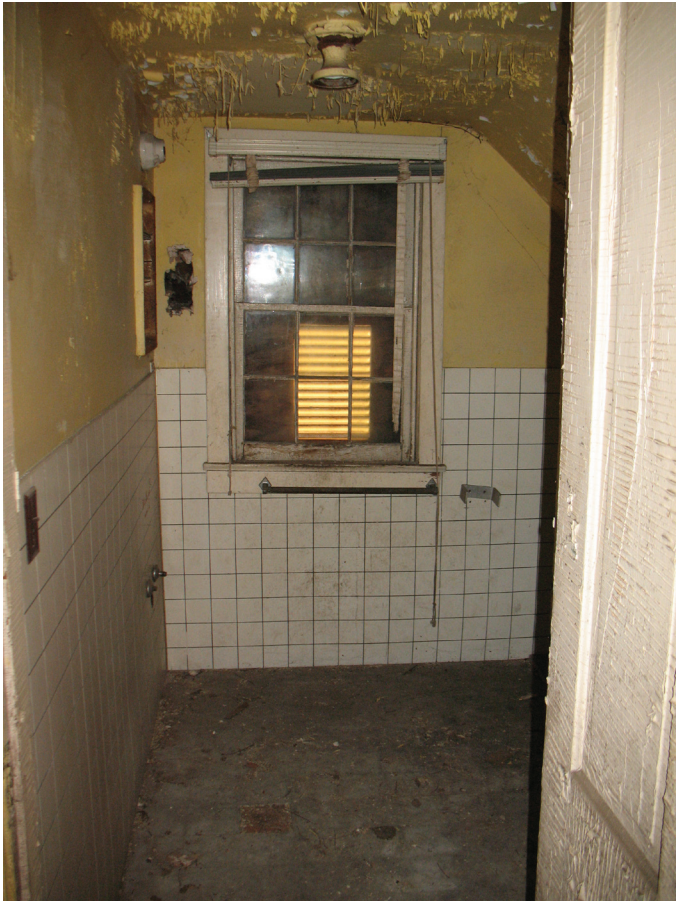
The bathroom appears to be a later alteration. Any original plaster has been replaced with new plaster on rock lathe. The floor is finished in vinyl tiles that are 5" square (206-1). The window has six-over-six light pattern with flat trim. The wall finish is a vinyl sheet good with a ceramic tile pattern and also 4" x 4" ceramic wall tiles. There is no base trim (206-2). The window has a six-over-six light pattern and flat trim. All of the finishes in the room are in poor condition.

View of window in second floor bathroom. (206-1)

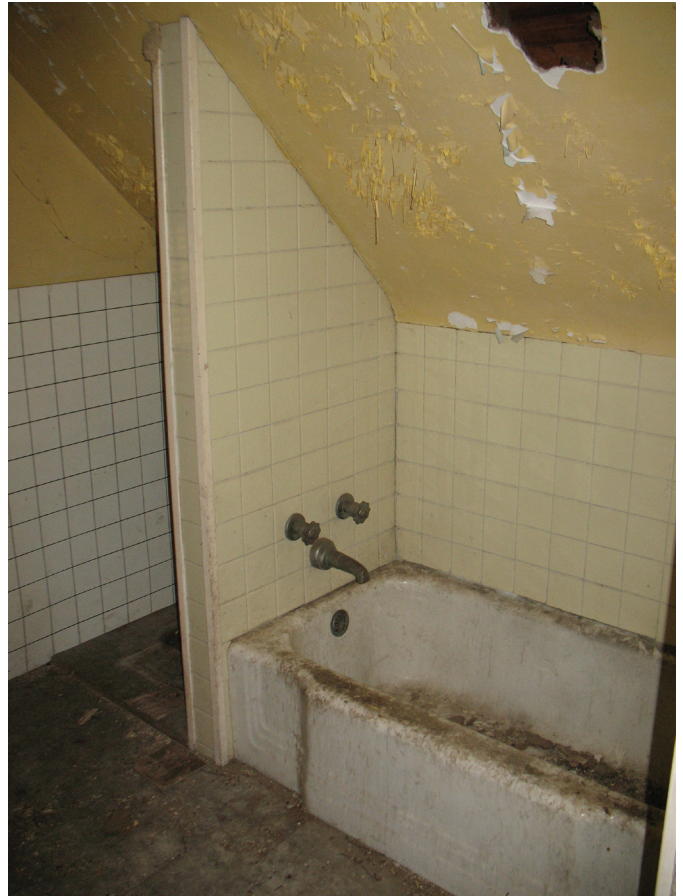
View of bathtub in second floor bathroom. (206-2)

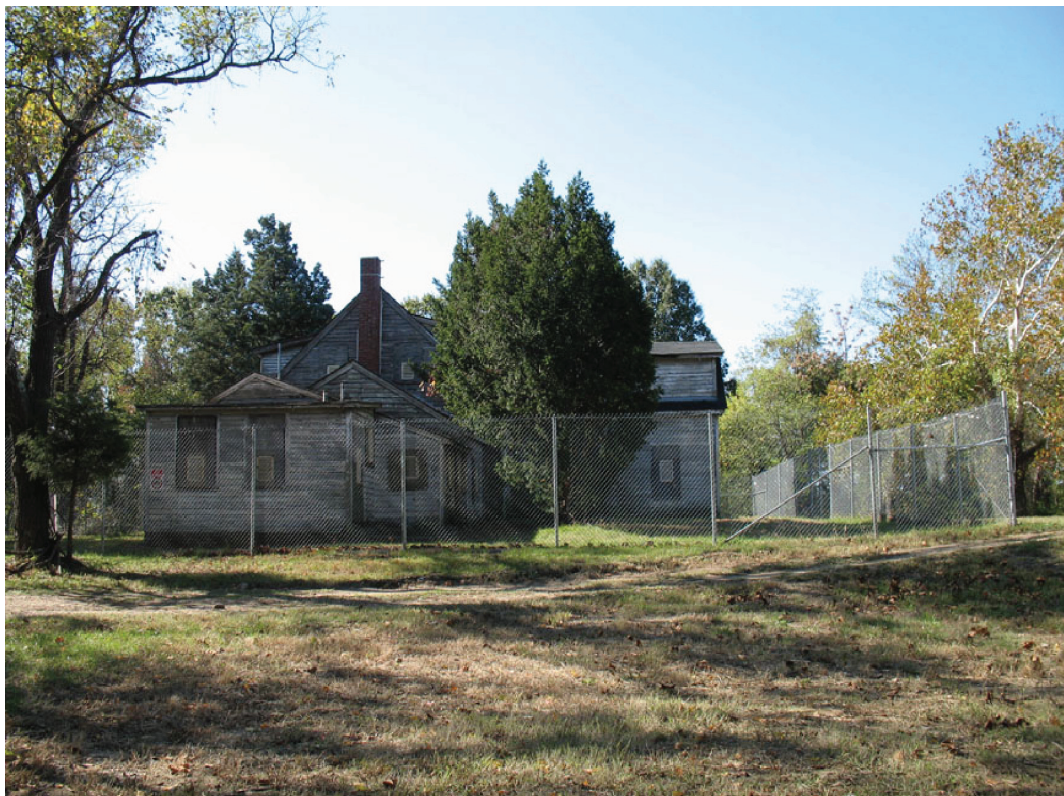
View of house from area near neoclassical gardens. (L-1)

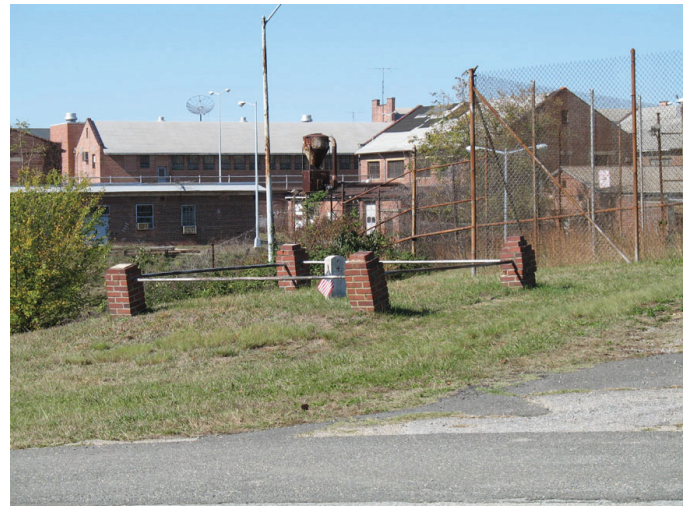
View of Lindsay family gravesite. (L-2)

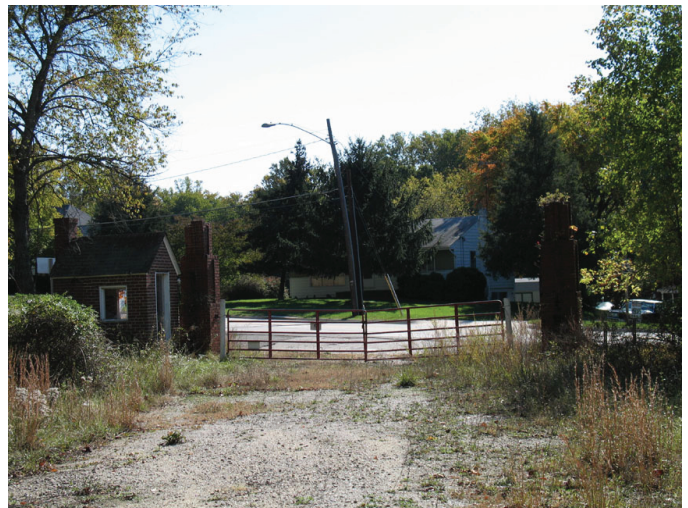
View of entrance to access road at intersection with Lorton Road. (L-3)

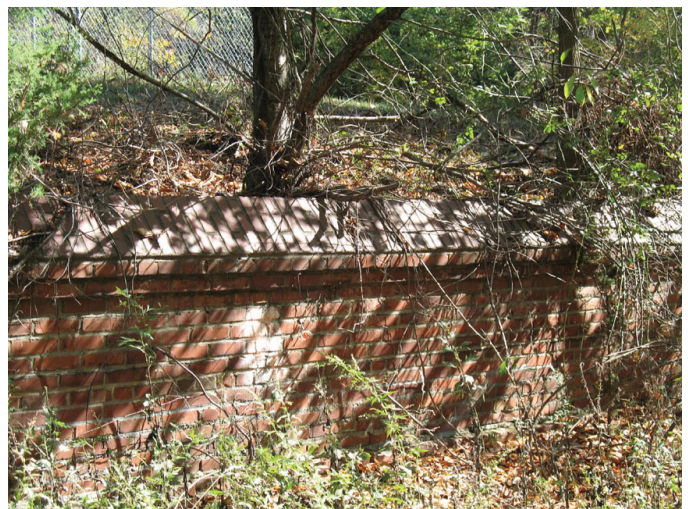
View of brick wall made of prison-era brick along access road. (L-4)

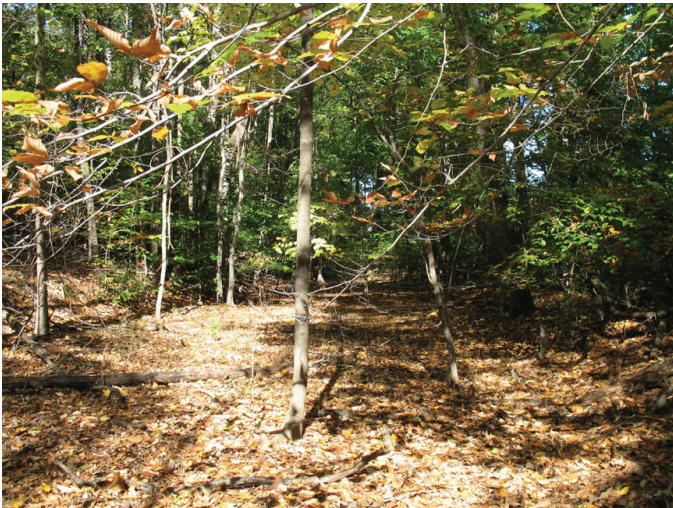
A temporary access road, now a trace, remains in the woods to the east of the house (L-5). It once served as a construction access route between Lorton Road and the Reformatory. The scar remains and, although somewhat wooded and eroded in spots, is still clearly visible. In some swaths, it is up to thirty feet wide. Separating soon after crossing the low bridge along the old Reformatory Access Road just north of Lorton Road, the trace alignment follows the western edge of the adjacent stream bank.

View of trace remaining from construction access road. (L-5)
